STEP 1.6 CASE STUDY

Input-output imbalances

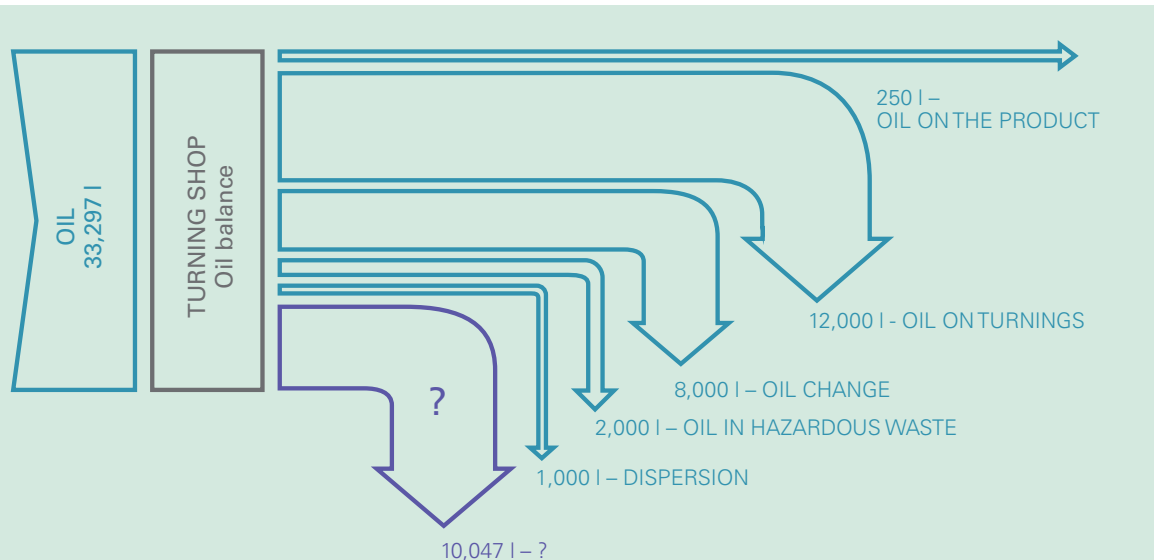
Figure 1

During step 1.4, an SME manufacturing ball bearings had identified cutting oils as one of the priority flows due to the associated high annual financial loss. During step 1.5 the turning shop had been identified as the cost centre with the highest NPO costs, and it was selected as a focus area. In step 1.6, the material flow balance for cutting oil was completed for the turning shop, using both measured and estimated data. The mass balance could not be closed as a significant amount of cutting oil, corresponding to approximately 30% of the total input, appeared to be lost “somewhere” in the company, as illustrated in the figure 1.

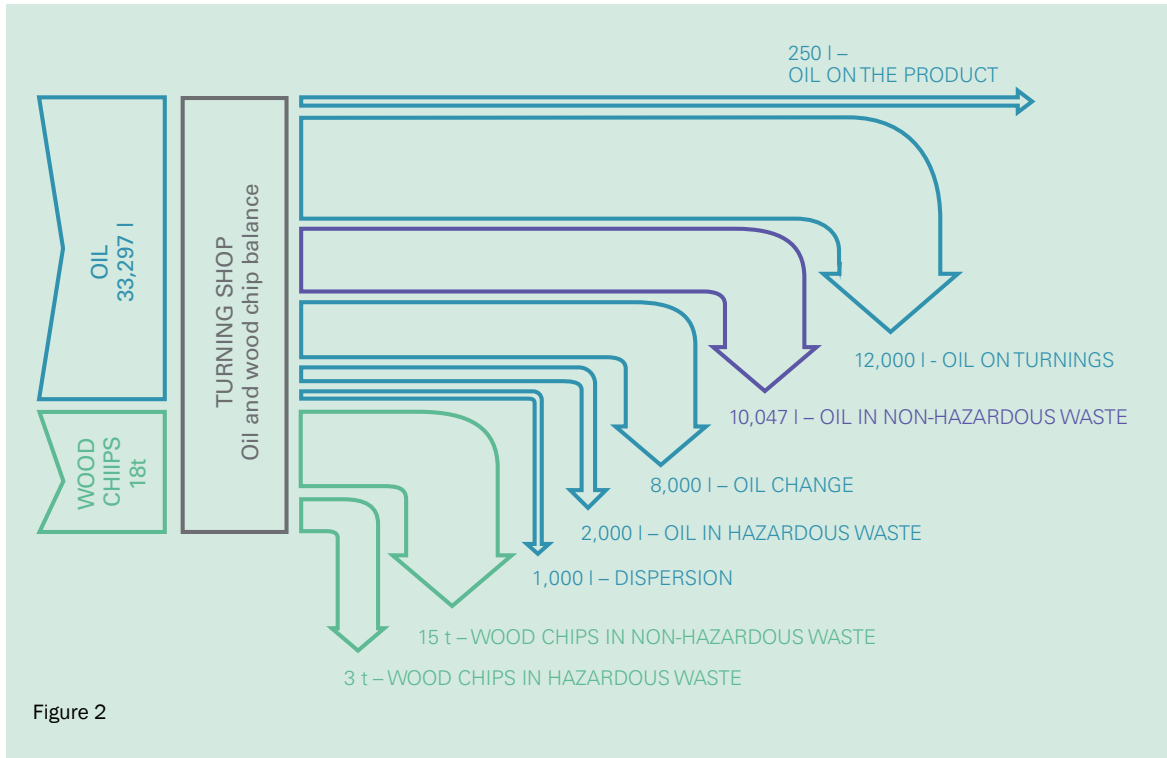
The detailed analysis at this step enabled the TEST Team to identify a set of resource efficiency measures. In addition to the obvious good housekeeping measures, new cleaning methods and procedures for recovering used oil from the turnings were also defined. Figure 2 shows the new complete balance.
